Research Brief

October 1997 No. ESC-04

Installation of Soil-Pinned Geosynthetic Reinforcement for Slope Stabilization

The primary goal is to evaluate installation methods and long-term performance of a slope surface stabilization strategy based on soil pins and geosynthetic blankets.

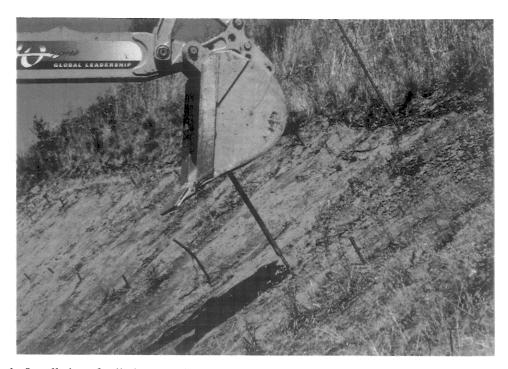
Figure 1. Installation of soil pins (No. 6, threaded steel rebar) using a backhoe bucket and driving sleeve; test site on US 95 south of Moscow.

- 1. The failed and rill-eroded cutslope was smoothed and dressed using a rubber-tired backhoe.
- 2. A regular, staggered pattern for the soil pins was laid out using a 2-m spacing; the pins then were pushed into the ground using the backhoe bucket and a reusable, protective sleeve placed over each pin (Figure 1), and leaving about 4-6 inches of the pin exposed at the ground surface. A portion of the treatment area had weathered granitic bedrock near the ground surface, where the steel pins could not be pushed into the ground without damaging them.

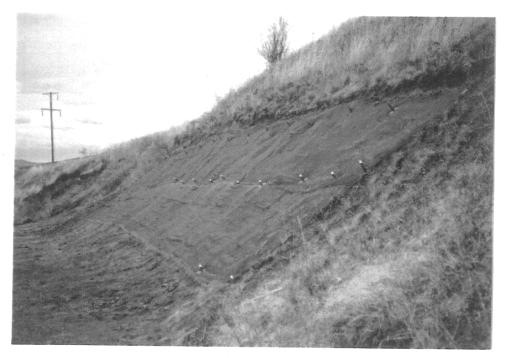
Figure 2. Geogrid-backed, synthetic erosion control blanket after hydroseeding treatment and post-tensioning of soil pins; test site on US 95 south of Moscow.

- 4. The steel pin assemblies were pushed/pounded into the ground an additional 2-3 inches with the backhoe bucket to tension the geogrid (Figure 2).
- 5. The project required 18 manhours and 7 equipment hr., bringing the total cost to \$17.55/sq.yd. (\$19.20/sq.m).
