Integrated Erosion Control Methods For Highway Construction And Slope Maintenance

**FINAL REPORT
March, 1999**

**FMK 745 FC No. 97-02
Report # N99-01**

**National Institute for Advanced Transportation Technology
University of Idaho**

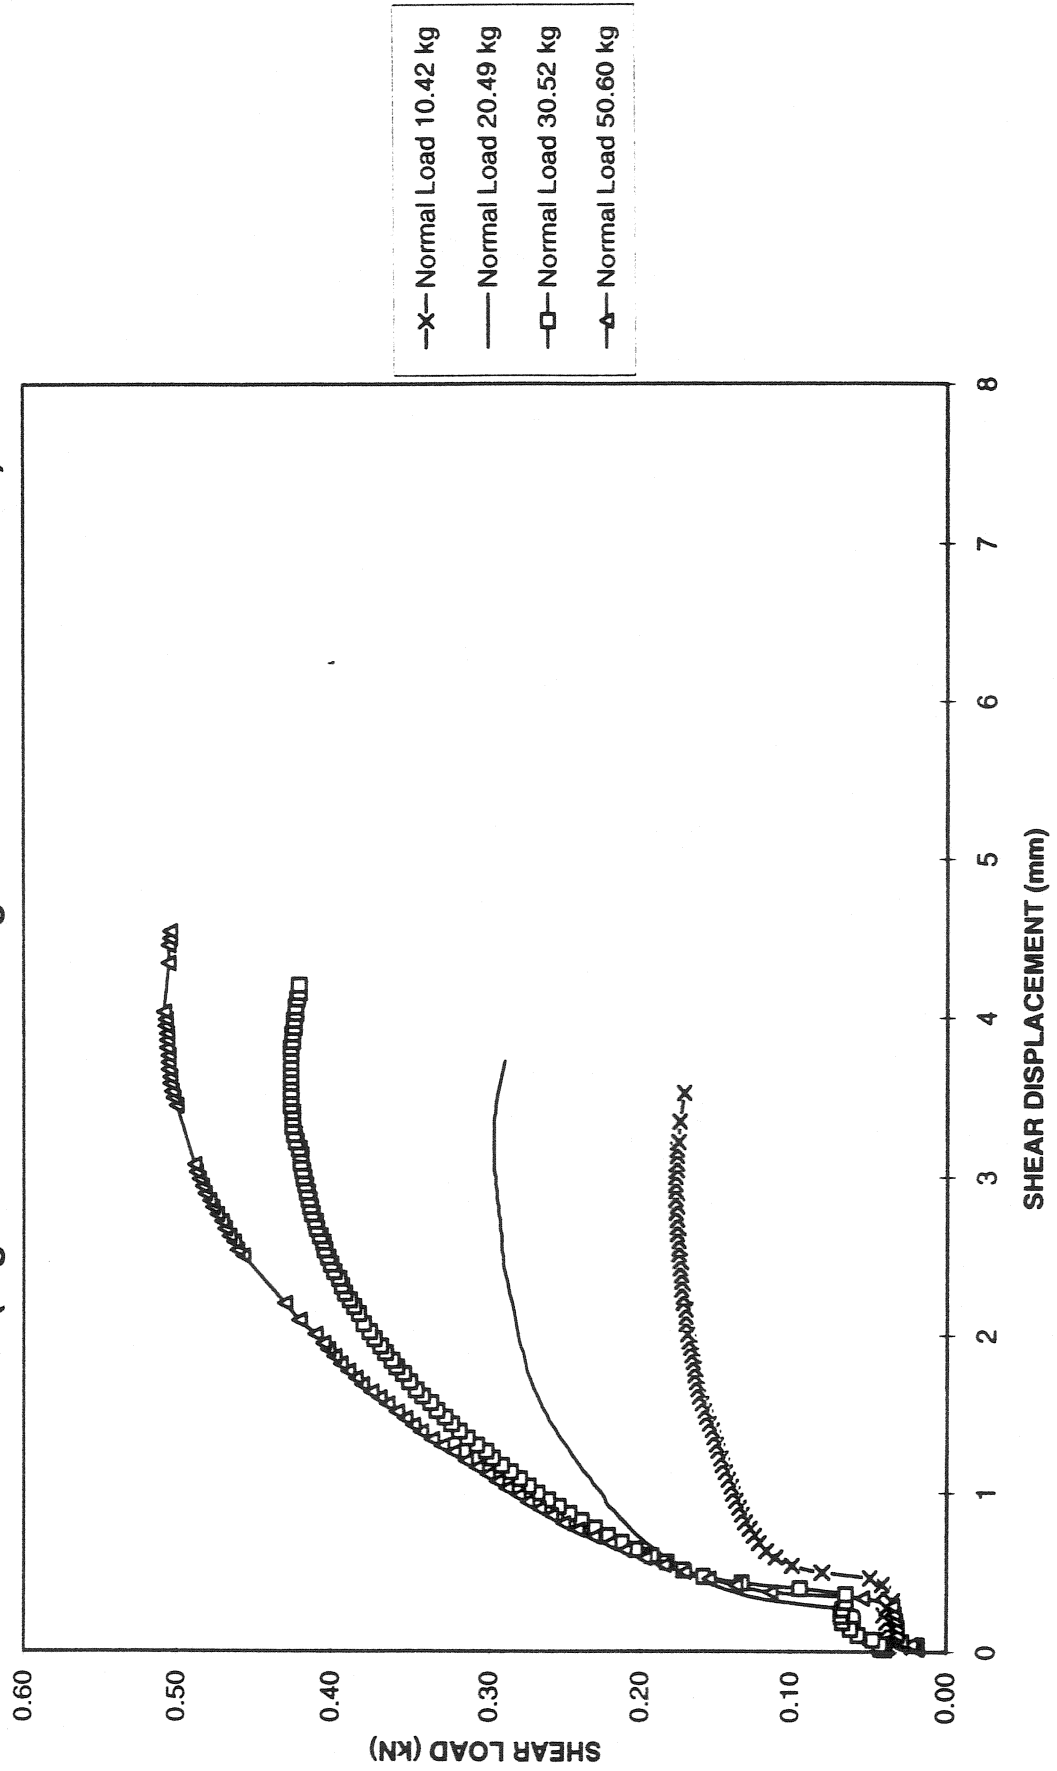
Loess-1

(High Normals - Average Moisture Content 6.5%)

SOIL DIRECT SHEAR TEST (ASTM D3080)

The second phase of testing was more focused on lower levels of normal stress and the effects of submerging the test samples in a water bath during shearing. Examples of laboratory data sheets and load-displacement graphs for these direct-shear tests are given in Appendix A. Such graphs were used to develop the subsequent normal vs. shear stress plots, from which linear and power failure envelopes could be fitted by least-squares regression methods.

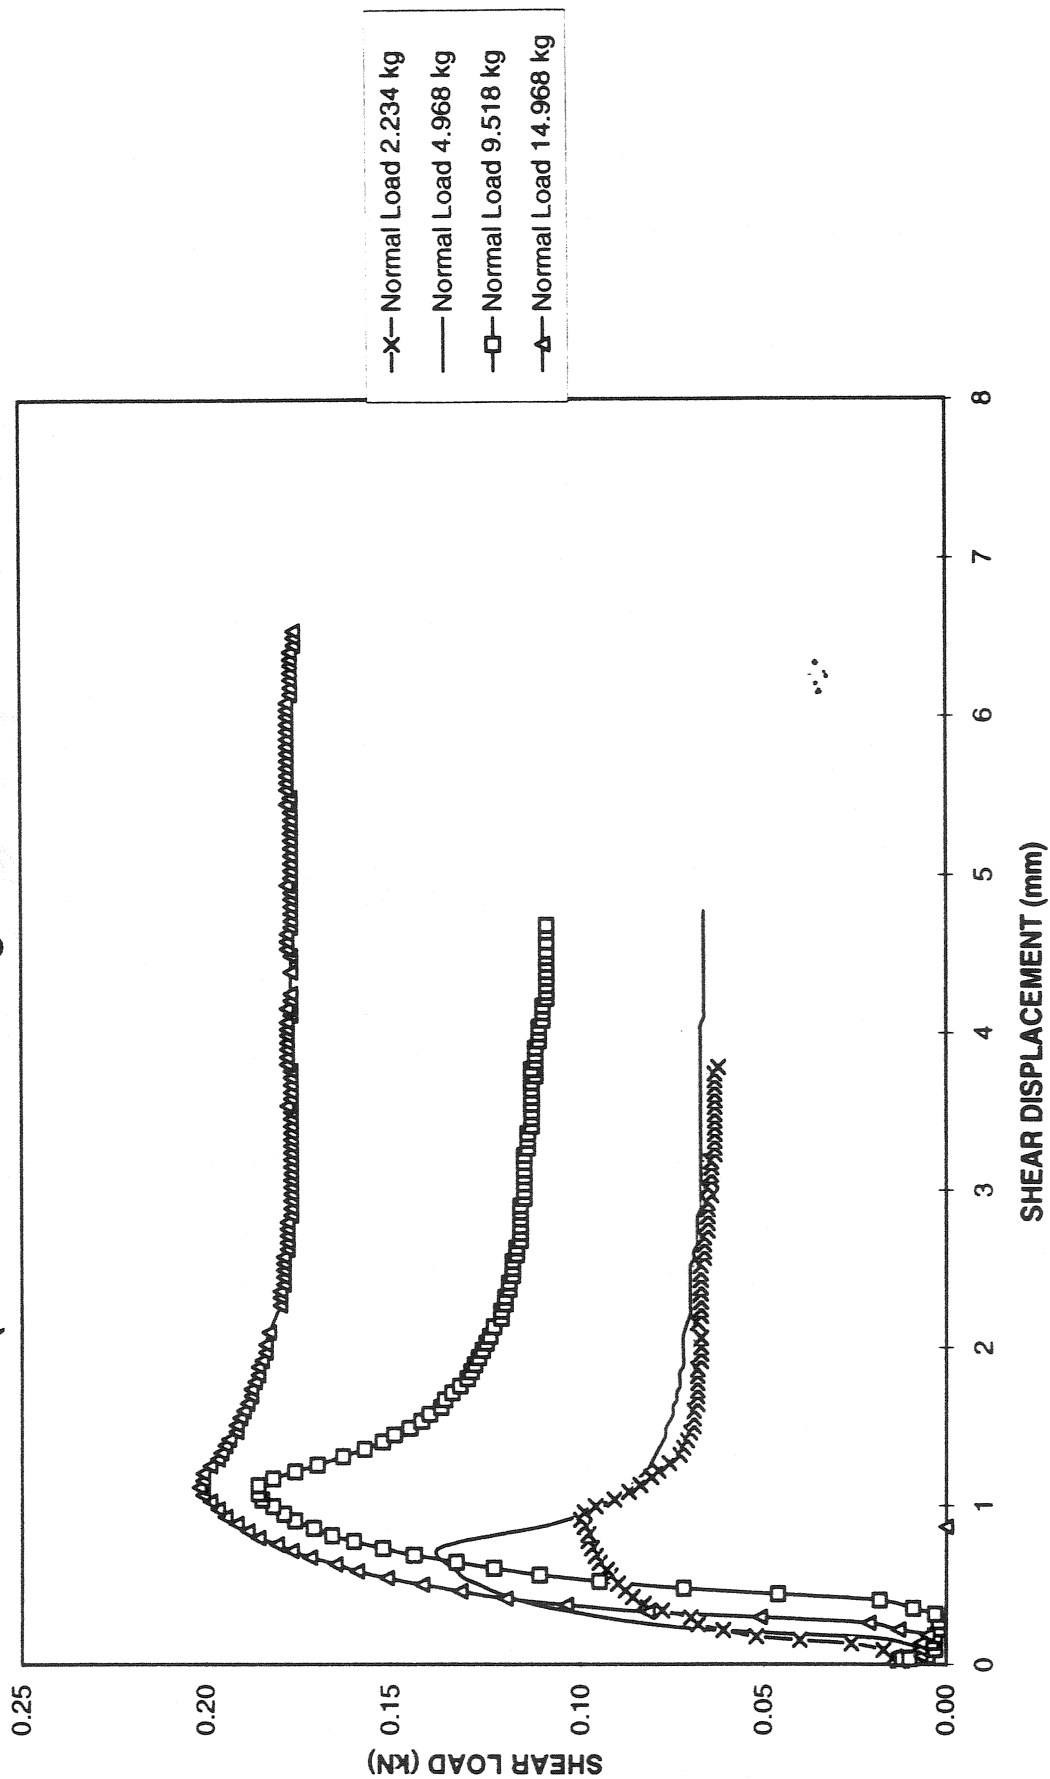
Loess-21

(Low Normals - Average Moisture Content 16.2%)

SOIL DIRECT SHEAR TEST (ASTM D3080)

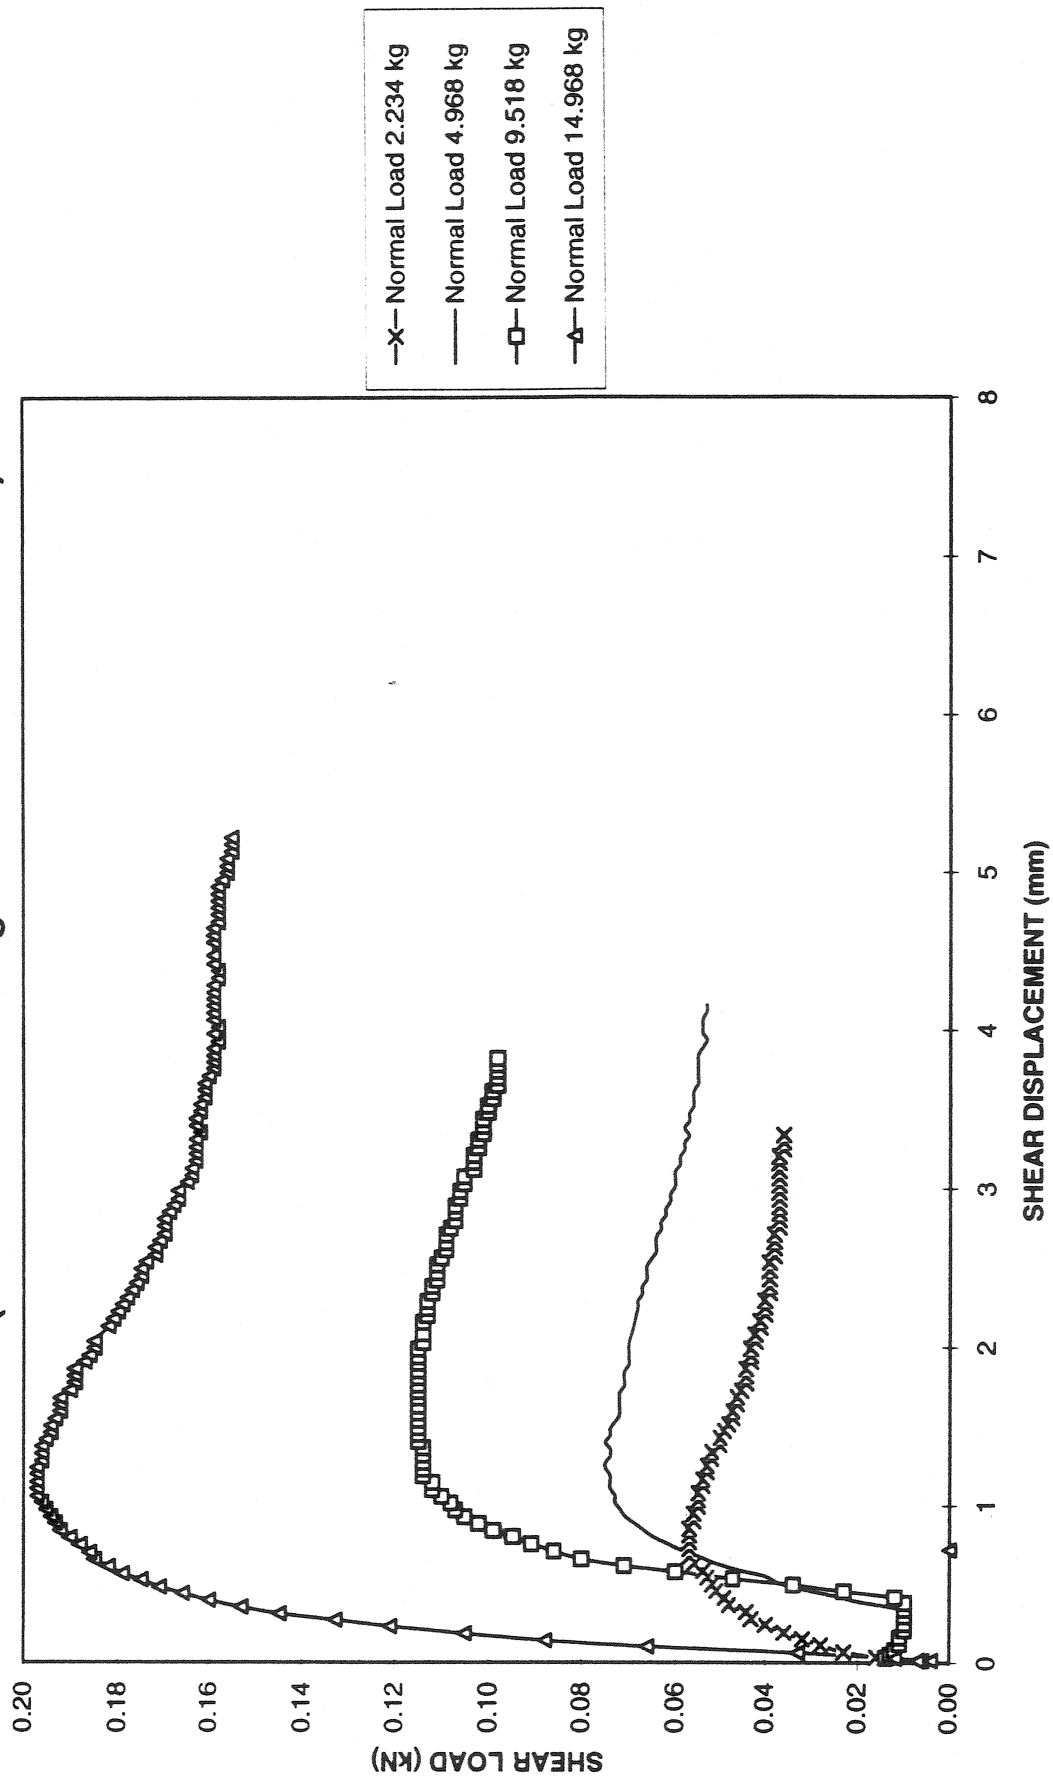
Loess-28

(Low Normals - Average Moisture Content 4.5%)

SOIL DIRECT SHEAR TEST (ASTM D3080)

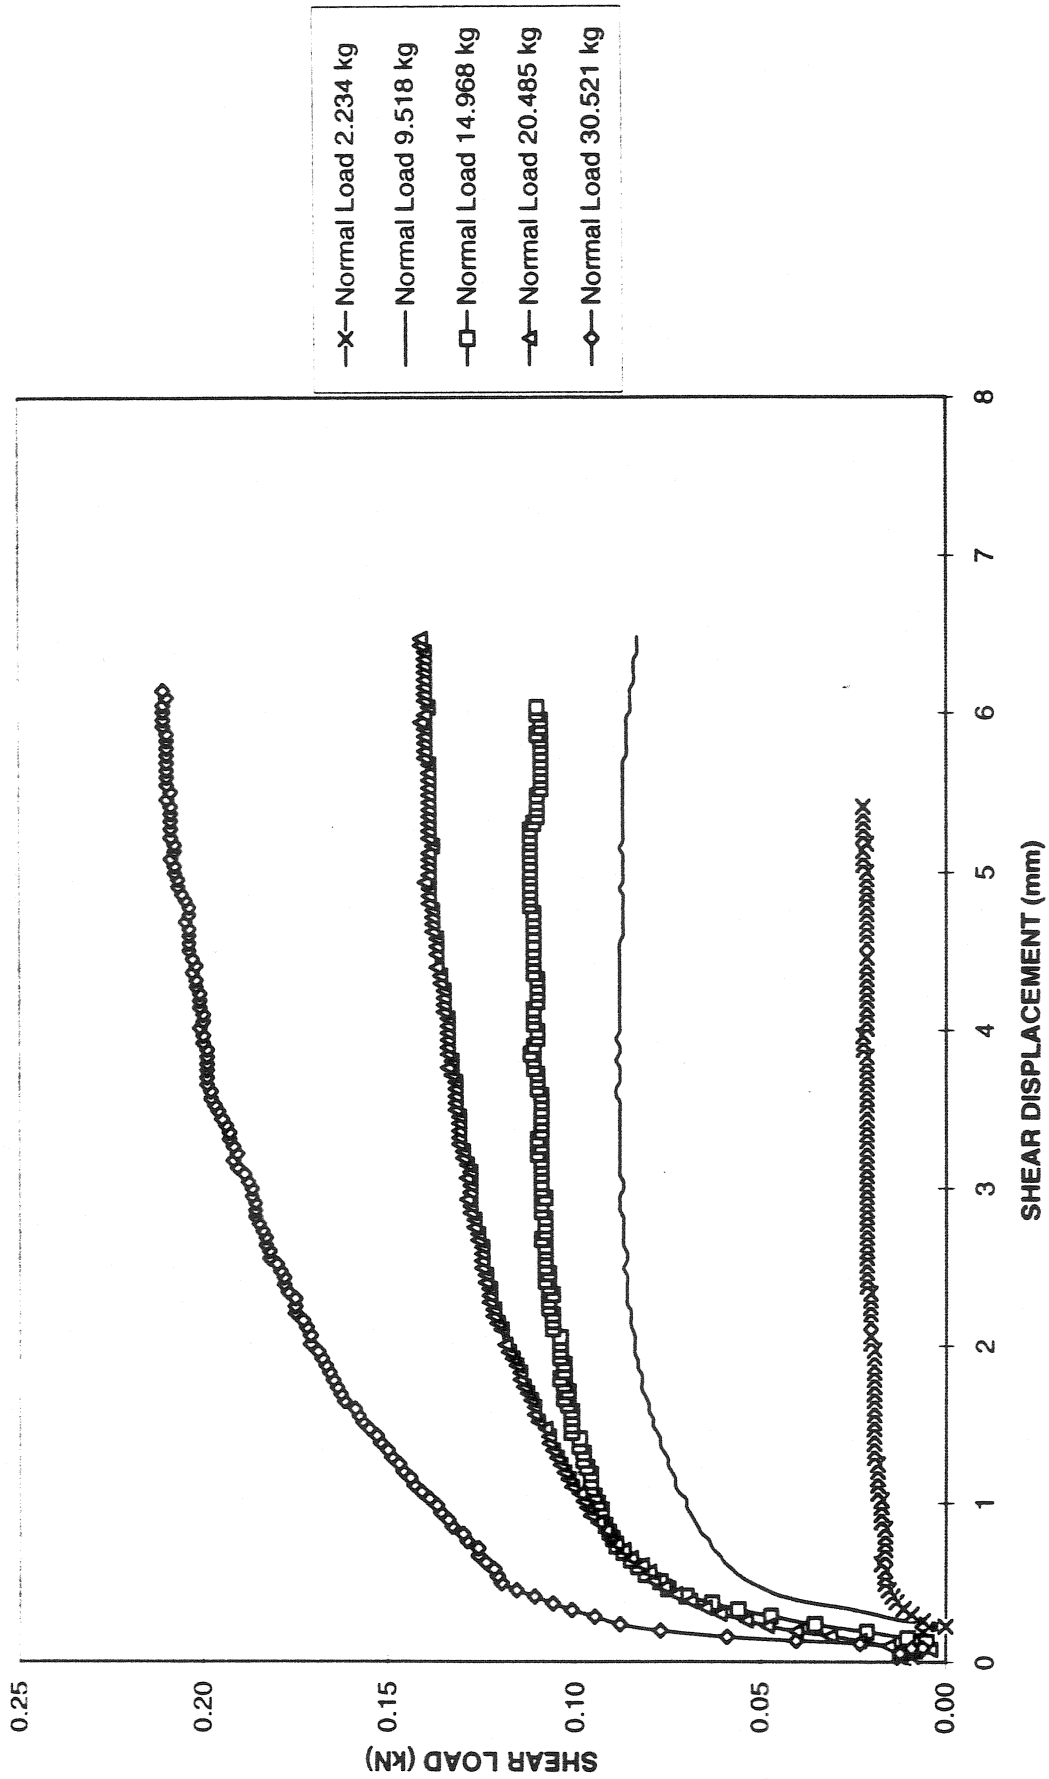
Loess-W1

(Wet - Average Moisture Content 27.2%)

SOIL DIRECT SHEAR TEST (ASTM D2488)

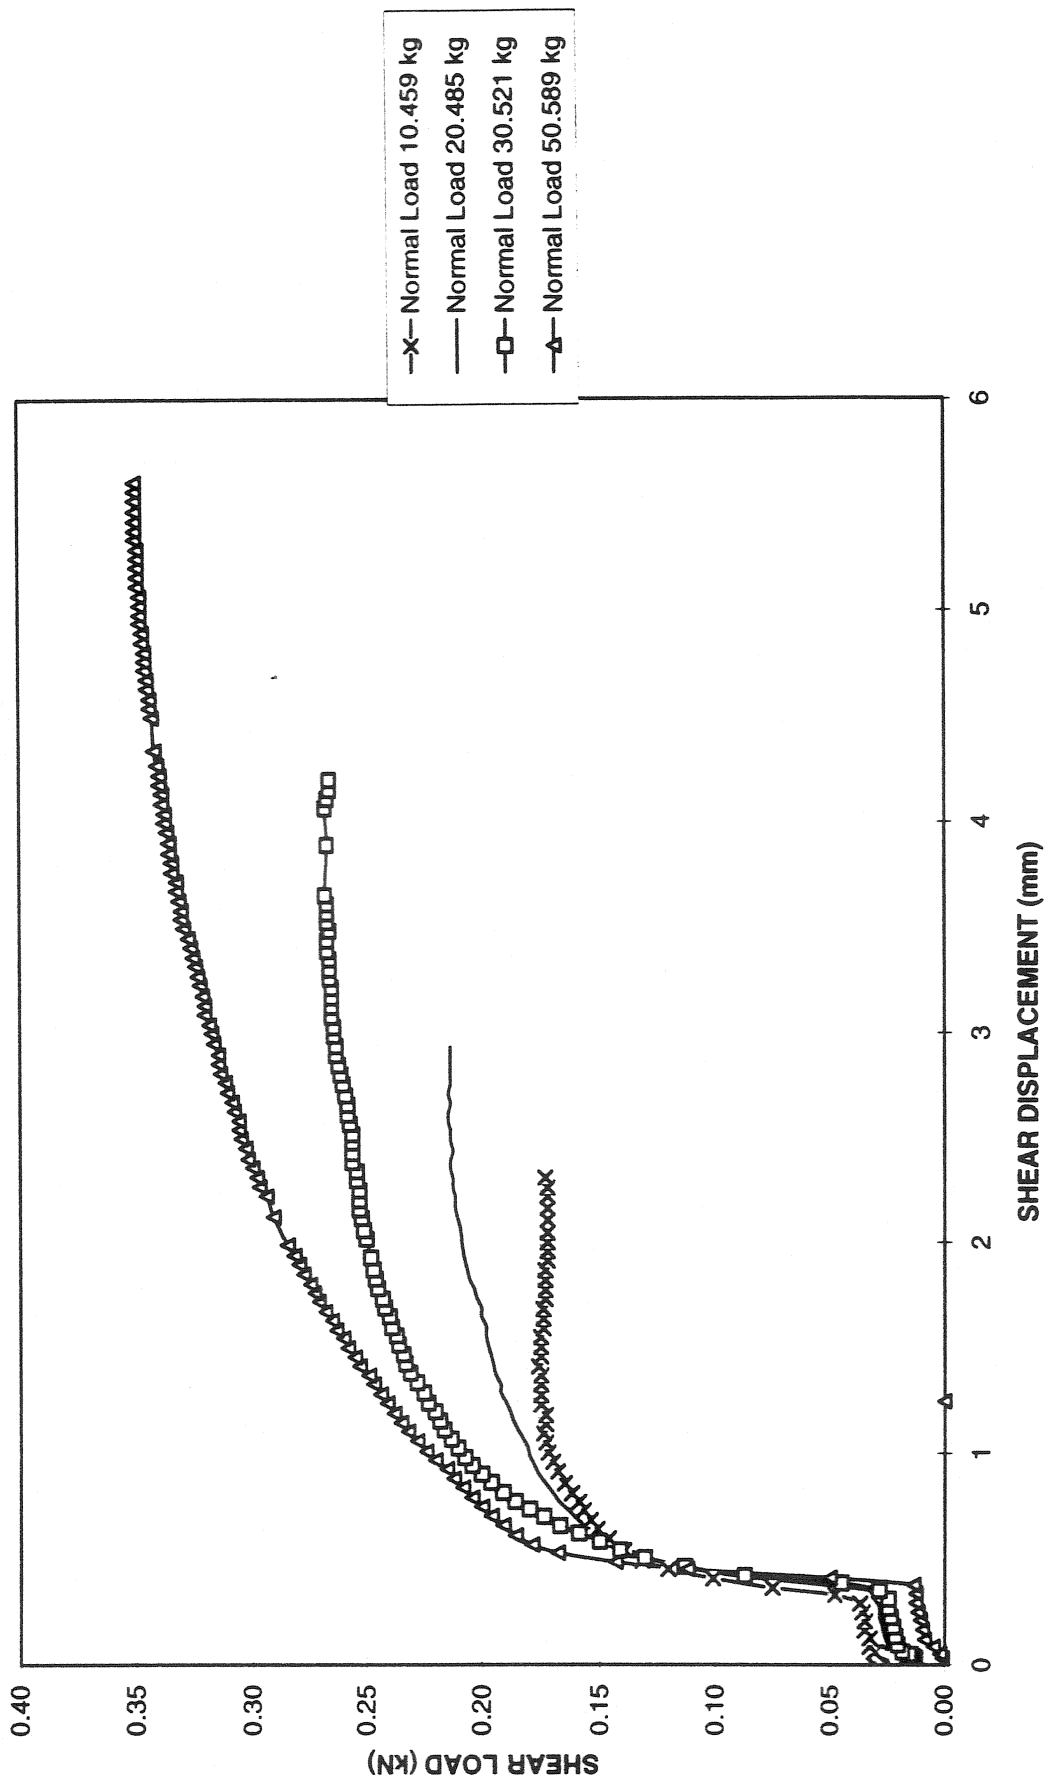
Sandpoint-5

(High Normals - Average Moisture Content 15.2%)

SOIL DIRECT SHEAR TEST (ASTM D3080)

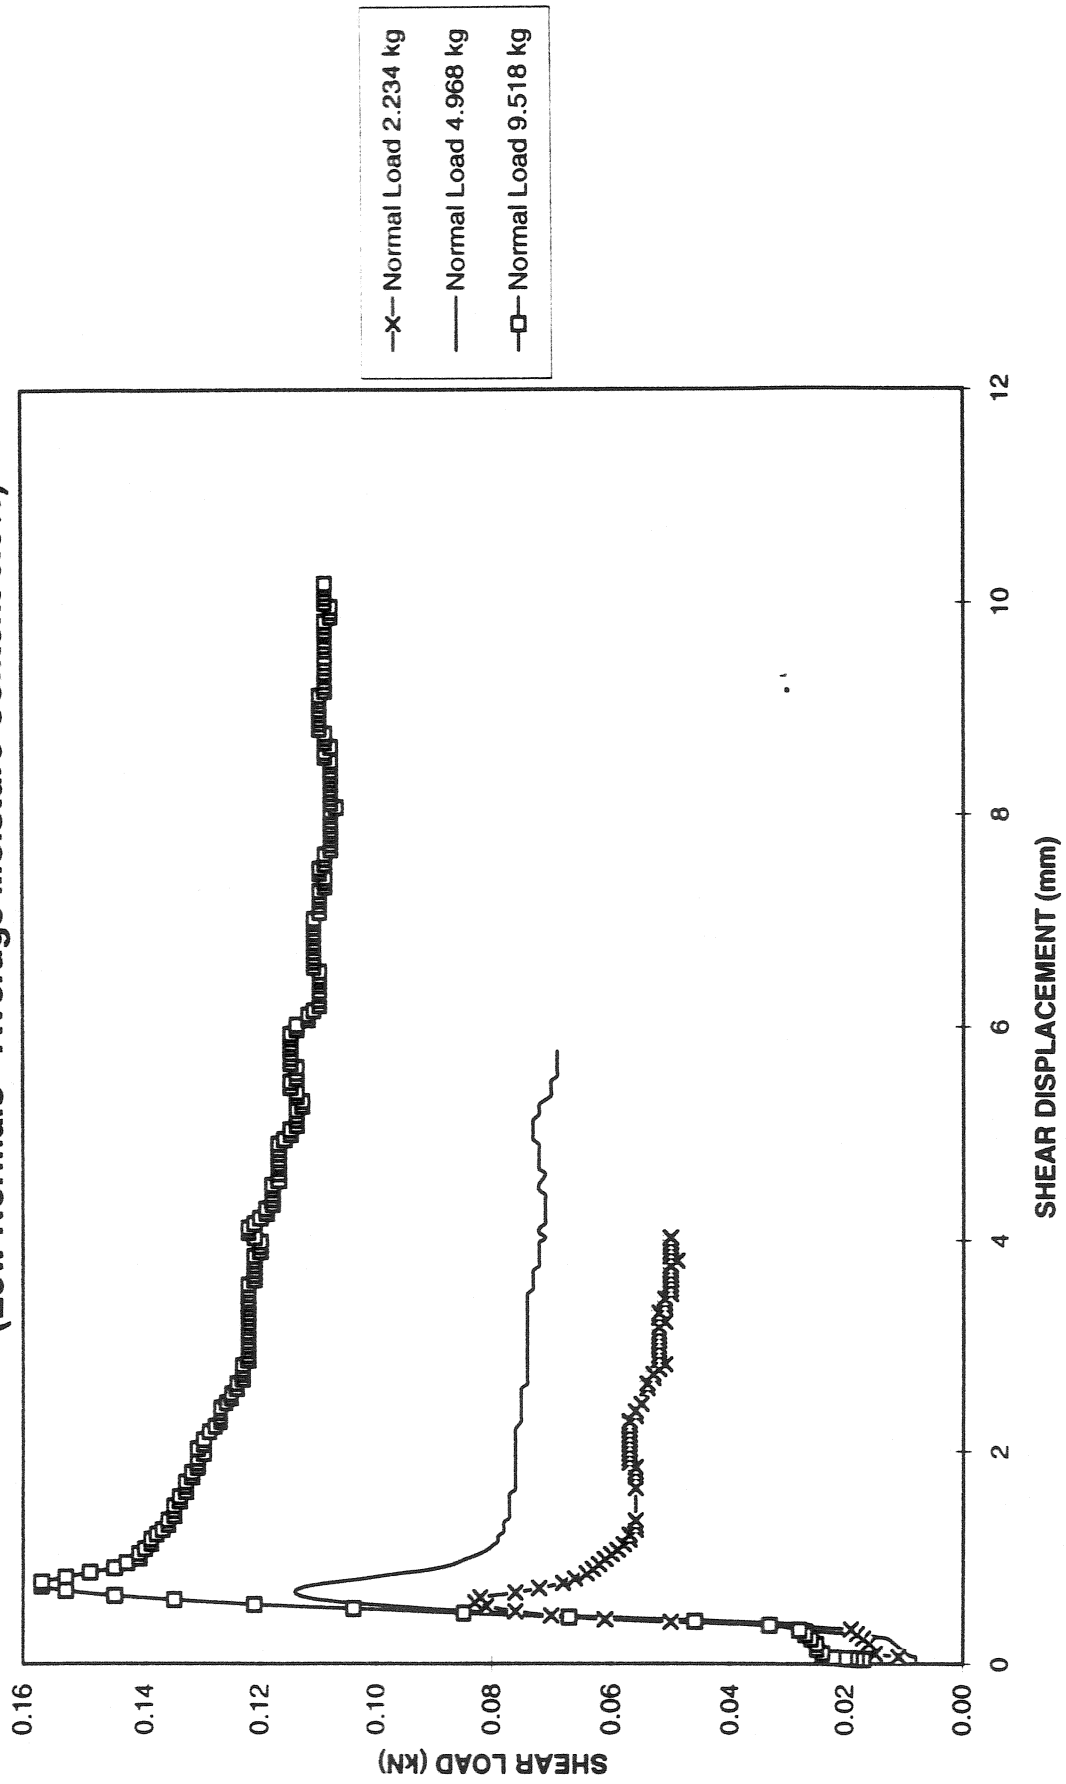
Sandpoint-11

(Low Normals - Average Moisture Content 9.6%)

SOIL DIRECT SHEAR TEST (ASTM D3080)

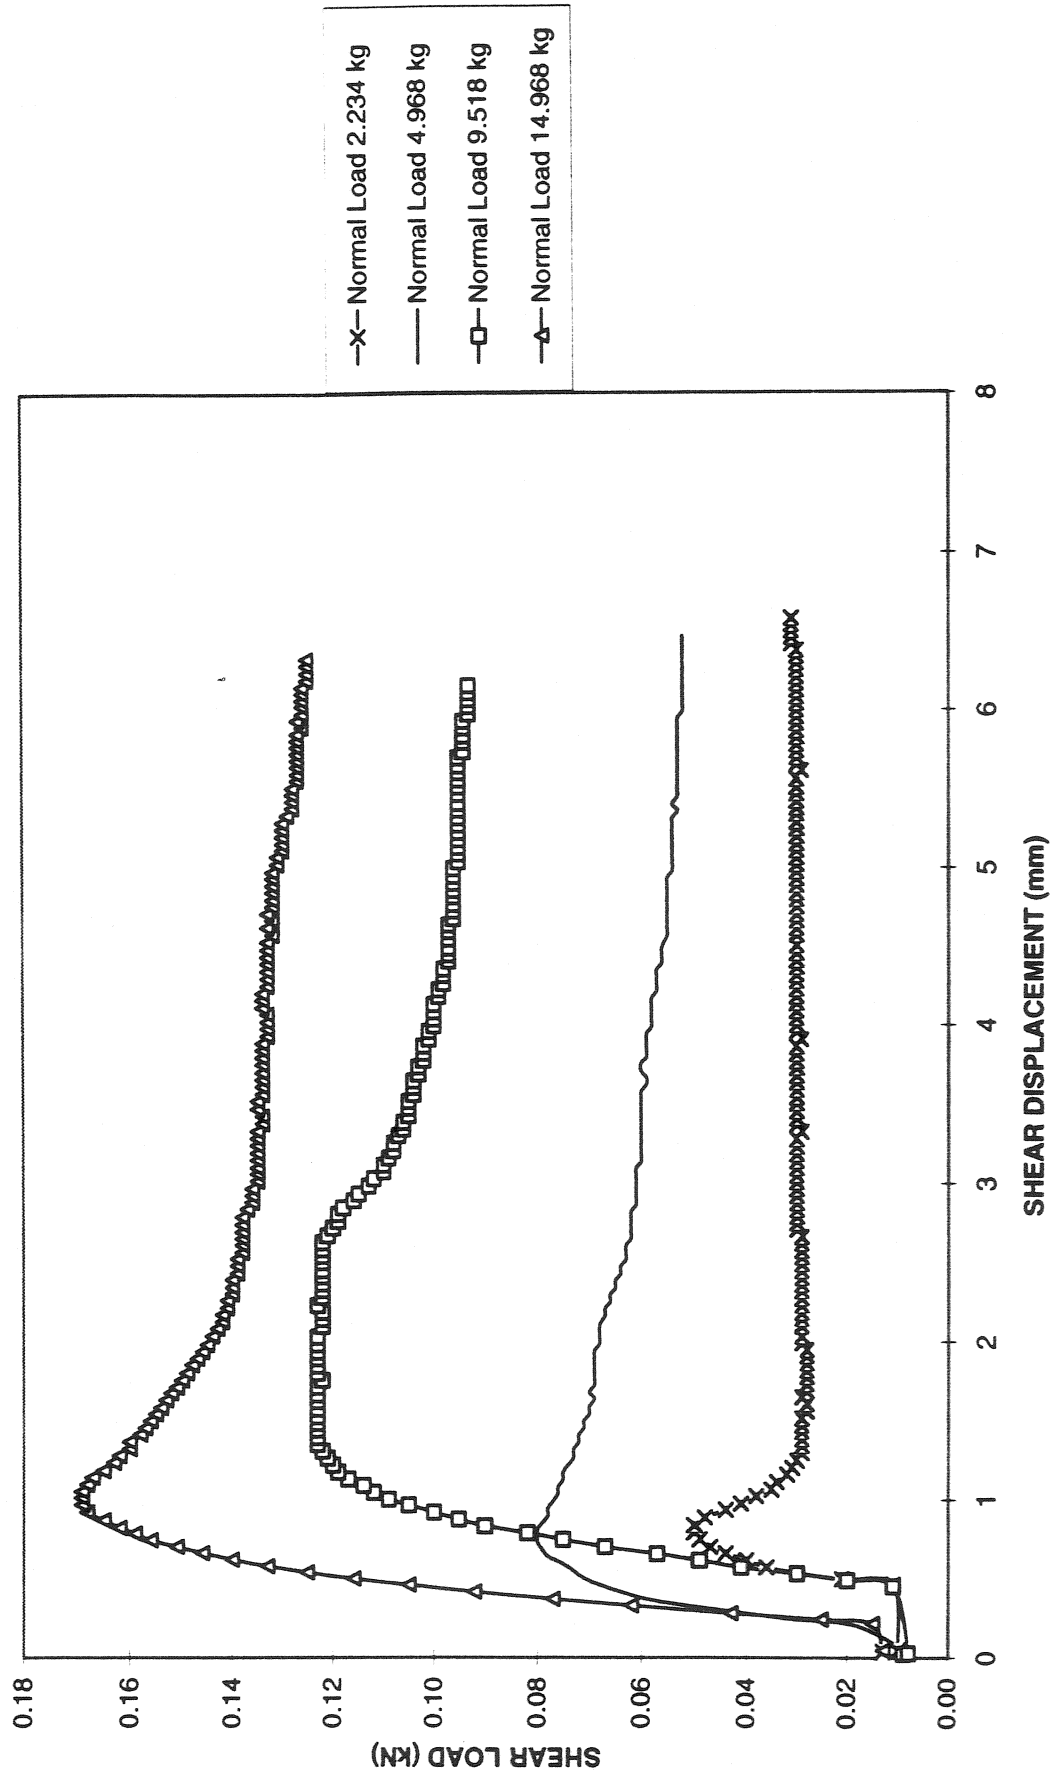
Sandpoint-20

(Low Normals - Average Moisture Content 15.2%)

SOIL DIRECT SHEAR TEST (ASTM D3080)

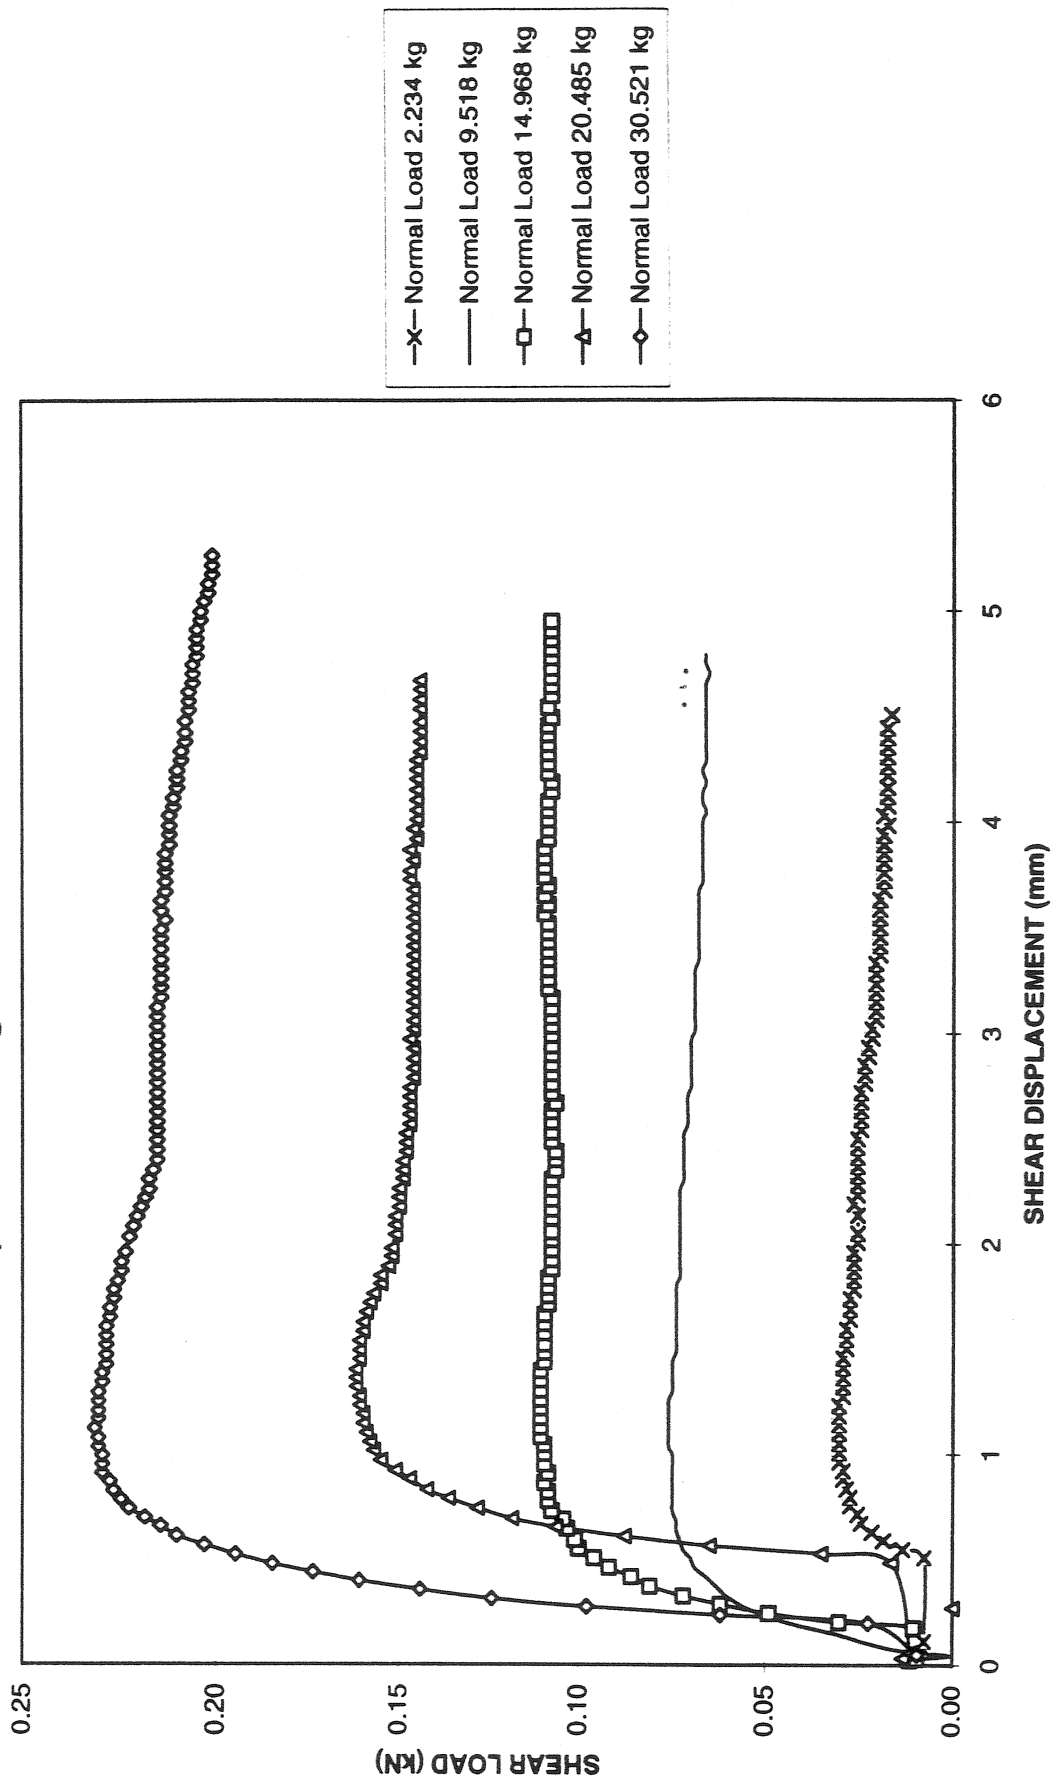
Sandpoint-w1 (Wet - Average Moisture Content 22.0%)

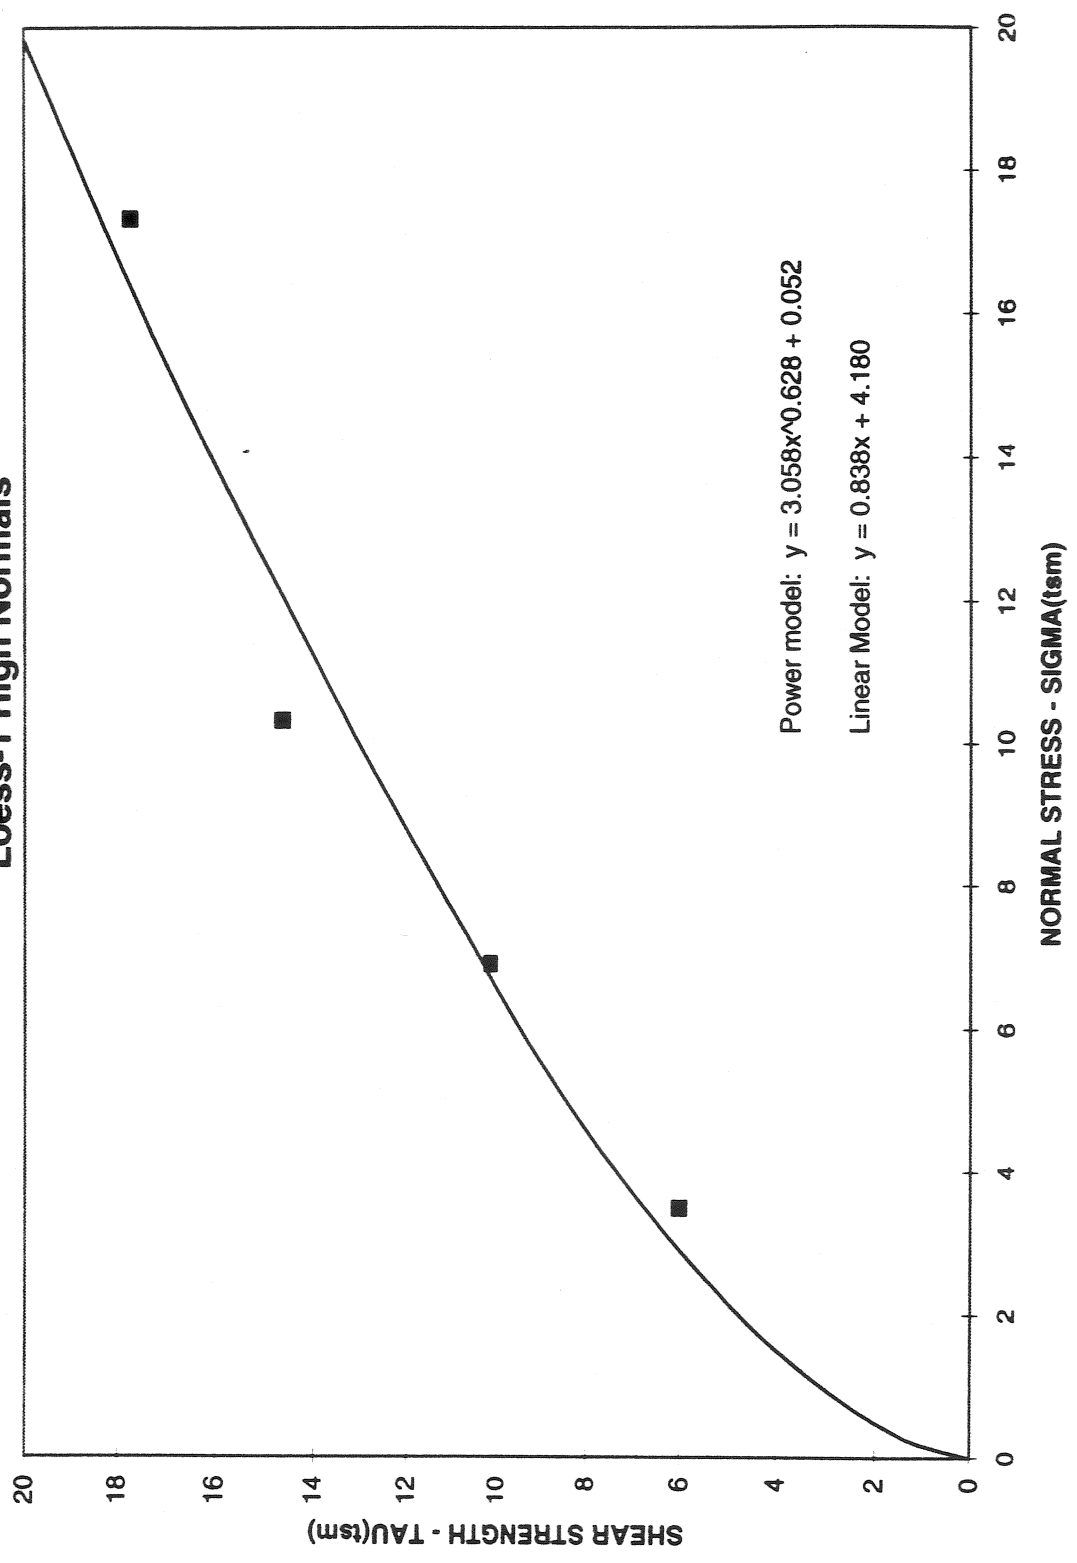
Loess-1 High Normals

Examples of normal-shear stress plots with regression models

Shear Strength

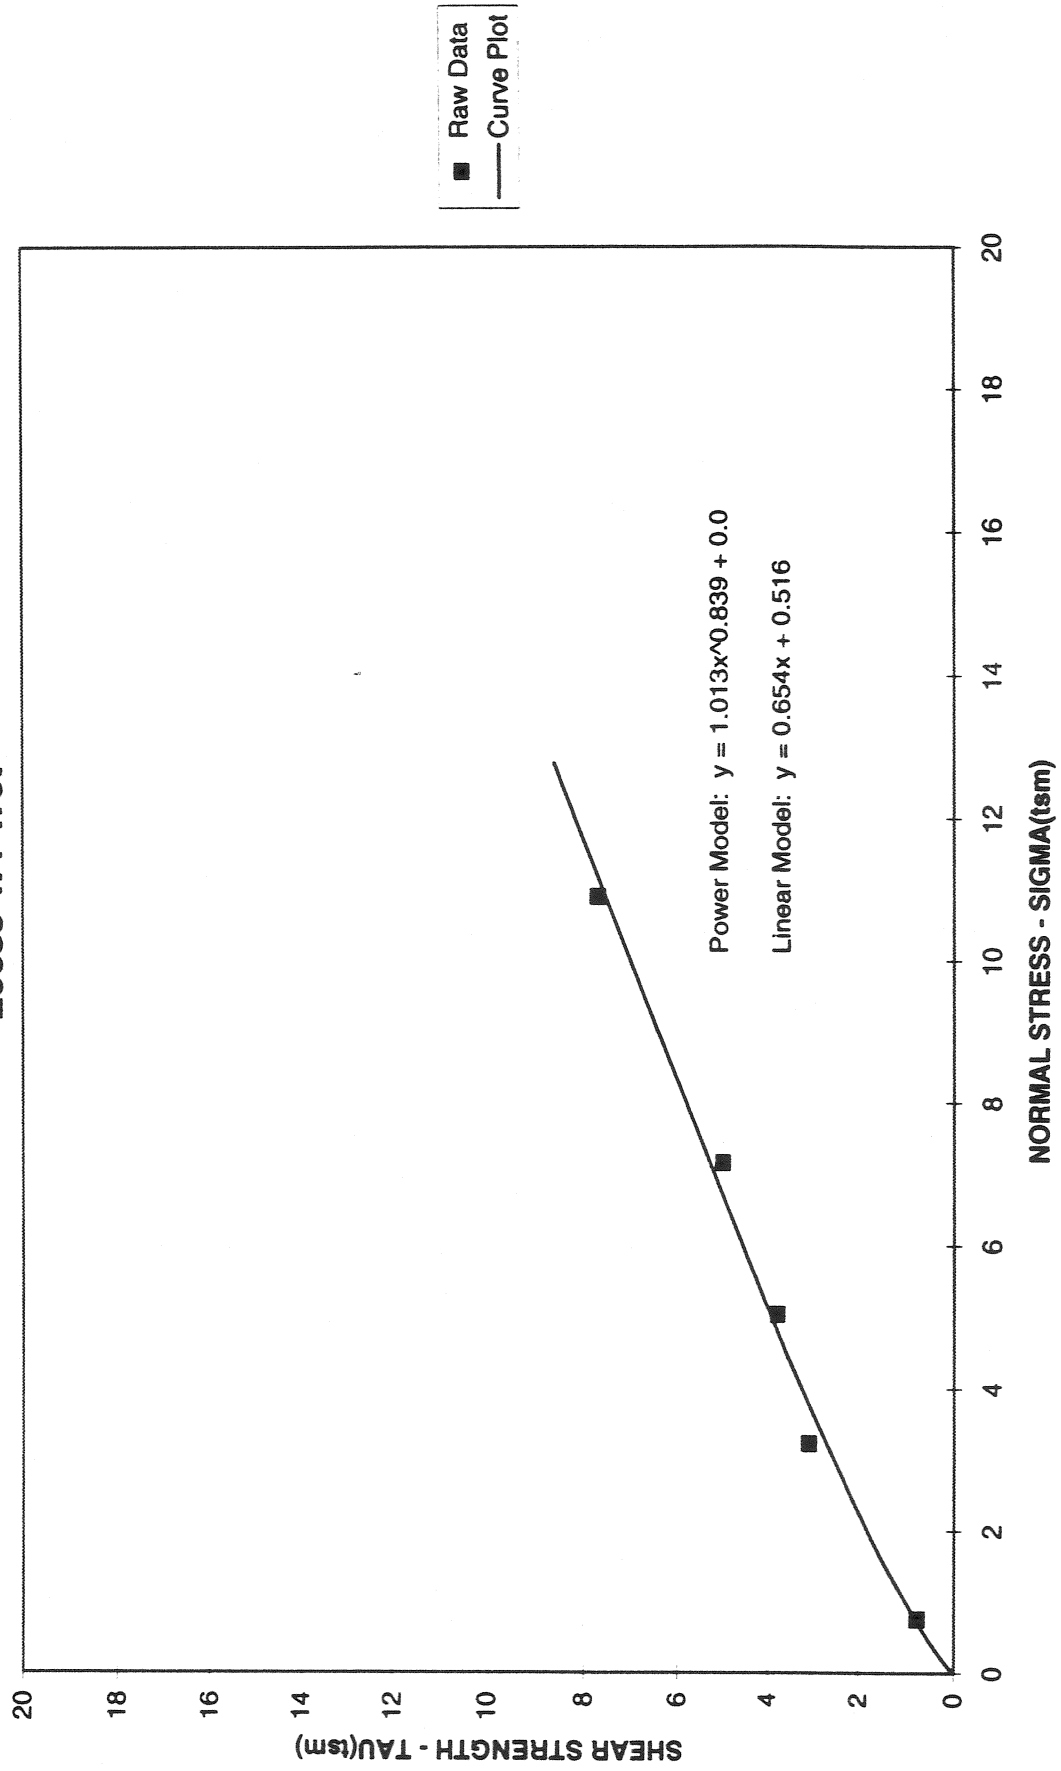
Loess-W1 Wet

Shear Strength

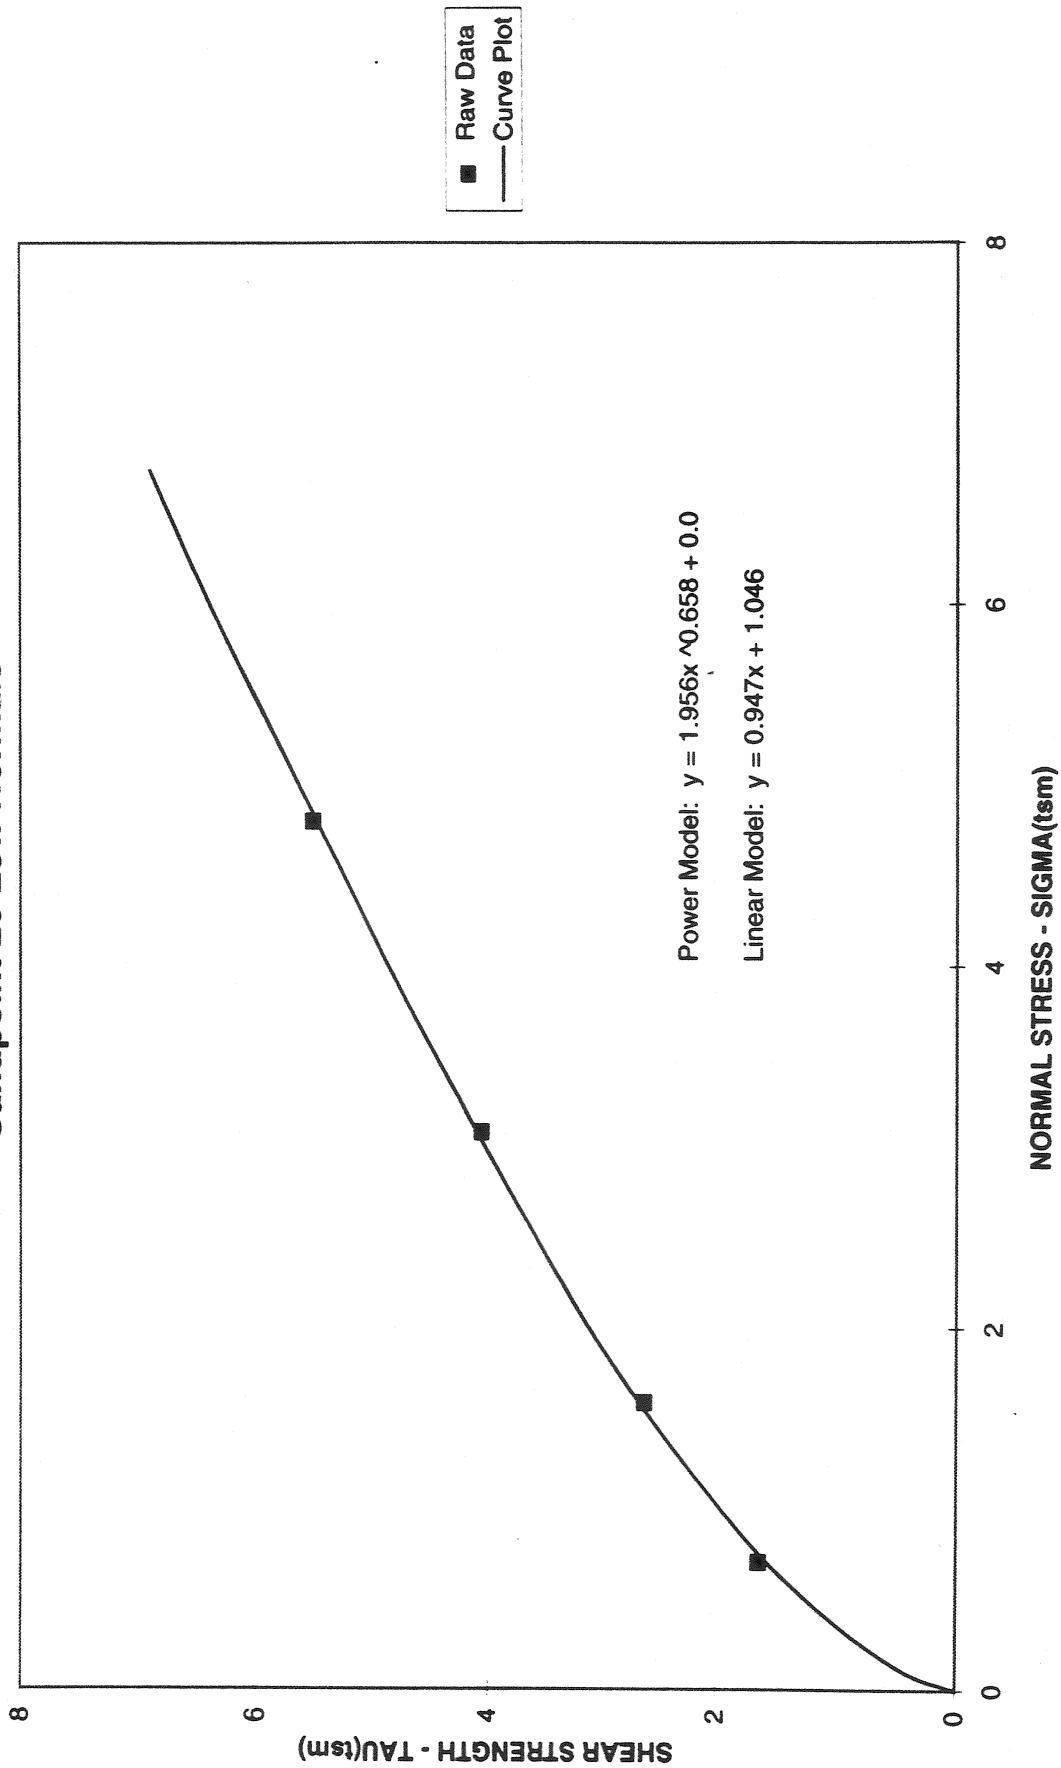
Sandpoint-20 Low Normals

Shear Strength

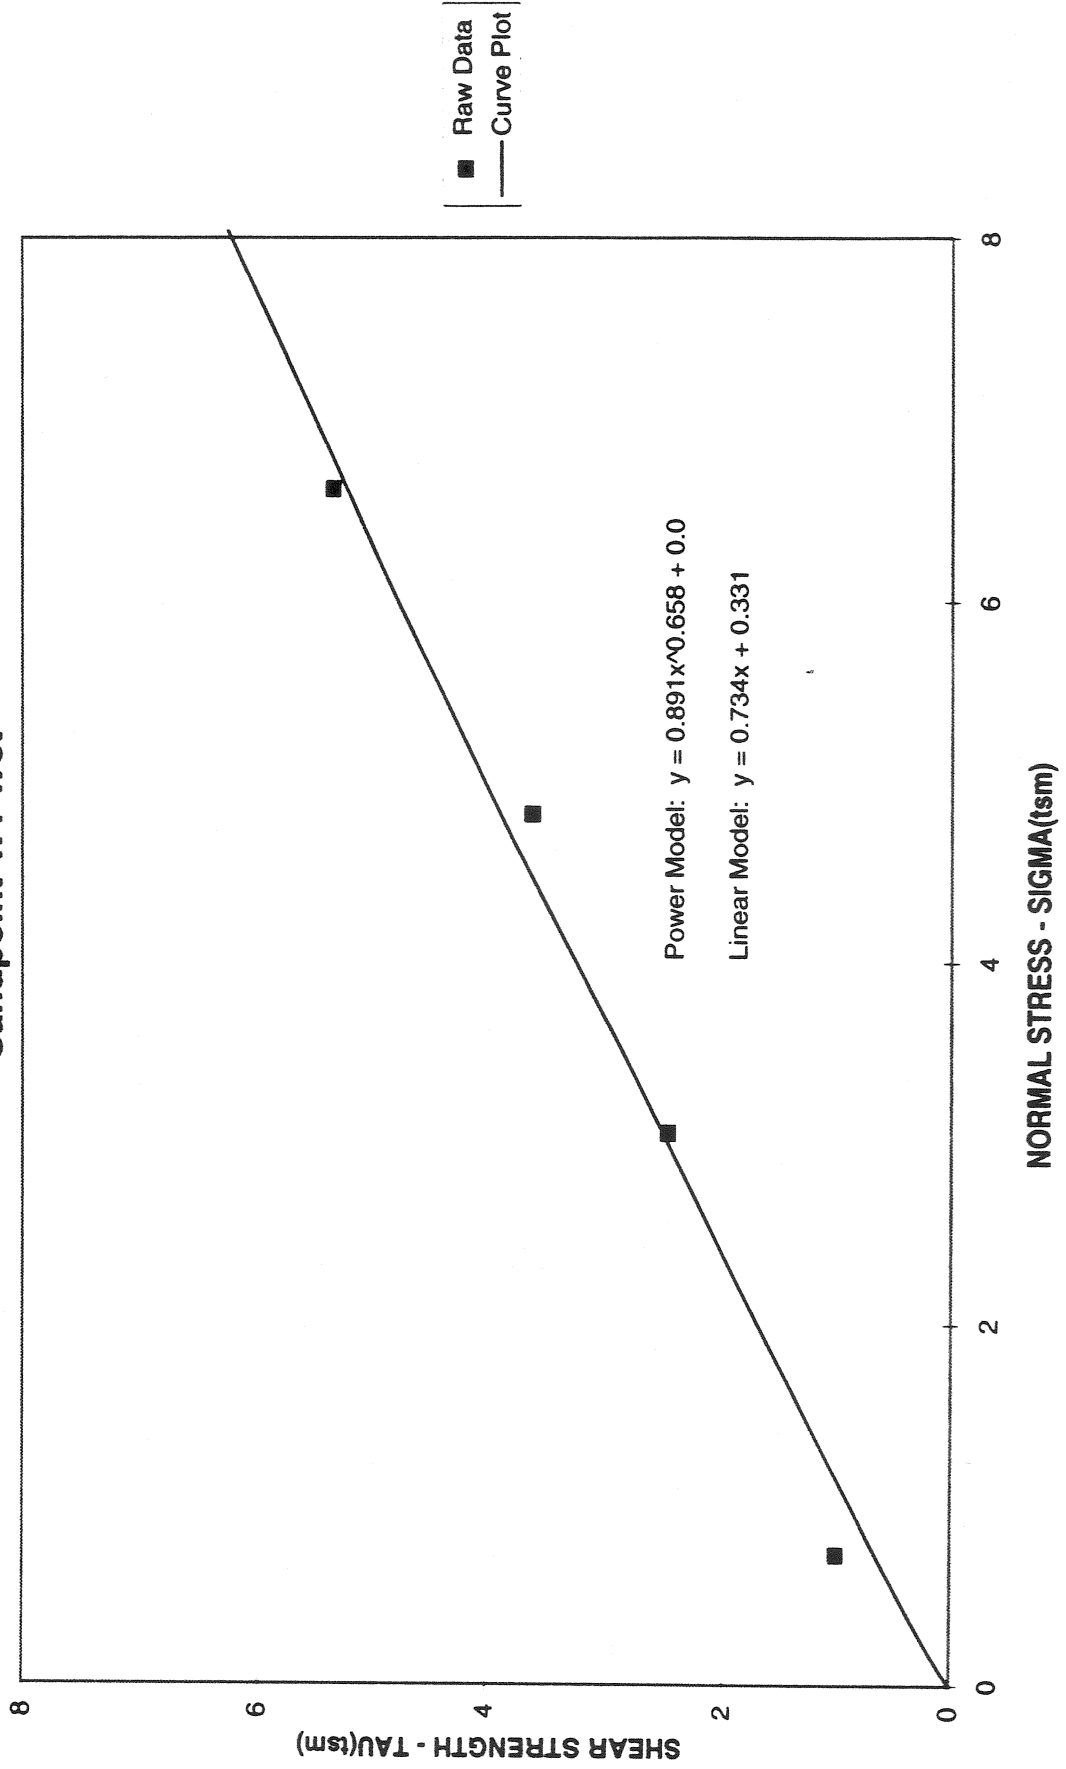
Shear Strength Sandpoint-W1 Wet
