SYNTHESIS INTO THE CAUSES OF CONCRETE BRIDGE DECK CRACKING AND OBSERVATIONS ON THE INITIAL USE OF HIGH PERFORMANCE CONCRETE IN THE US 95 BRIDGE OVER THE SOUTH FORK OF THE PALOUSE RIVER

Final Report
KLK491
Report N08-05
ITD Project RP157

National Institute for Advanced Transportation Technology
University of Idaho
for the
Idaho Transporation Department

June 2008

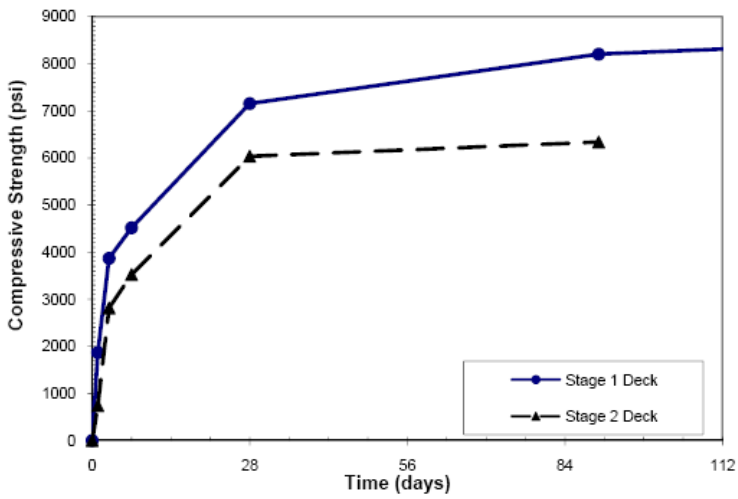
Figure 3-3: Compressive Strength of Bridge Deck Concrete.

The rate of compressive strength gain is presented in Figure 3-3. As shown, the compressive strength for the Stage 1 deck had nearly attained the specified design strength in 3-days and had surpassed 8000 psi at about 80-days. Although the rapid strength gain is beneficial for construction, it indicates that this mix will have high heat of hydration and high early modulus of elasticity, increasing the risk of transverse cracking. In contrast, the concrete for the Stage 2 deck had a slower gain in strength.

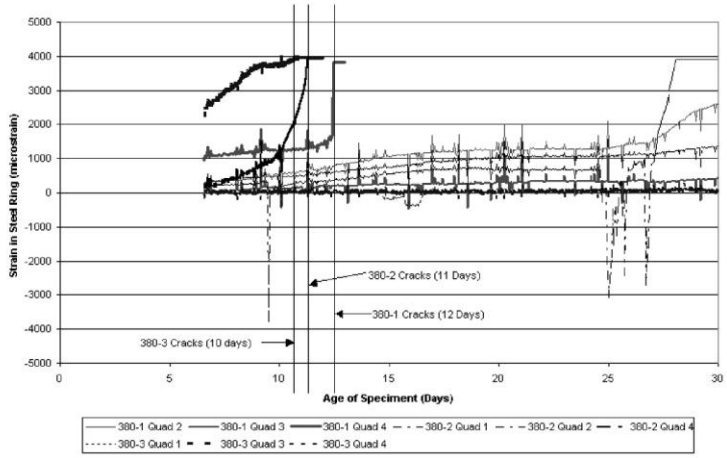
Figure 3-6: Cracking Potential Results for Stage 1 Deck Concrete.

According to the NCHRP 380 cracking potential test for the Stage 1 deck, restrained cracking occurs between approximately 10- and 12-days as shown in Figure 3-6. These results indicate that the concrete used in the Stage 1 deck will crack earlier than concrete from either Test Mix 1 or Test Mix 3, Test Mix 1 would be the best for restrained shrinkage, cracking at 22 to 24-days, while Test Mix 3 is next best at 18-days to cracking. Similarly, the NCHRP 380 results for the Stage 2 deck indicated that restrained cracking occurs between 3 and 11-days.

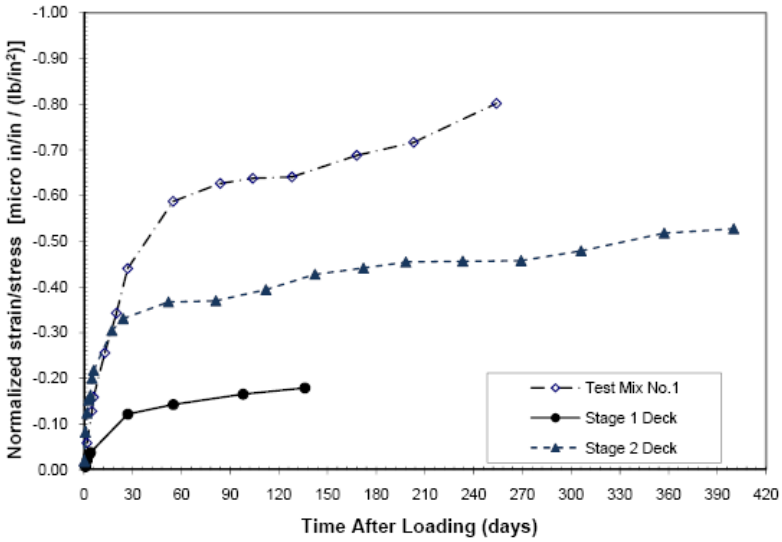
Figure 3-7: Normalized Creep Strains.

Figure 3-7 shows the results of this test. Comparing the creep of the Stage 1 deck concrete to that of the Stage 2 deck concrete or the concrete from Test Mix 1, it becomes apparent that the Stage 1 deck concrete has a much lower creep rate than the other two mixes. At 28-days after loading, the deck concrete has crept only about -195 microstrain as opposed to -794 microstrain for Test Mix 1.

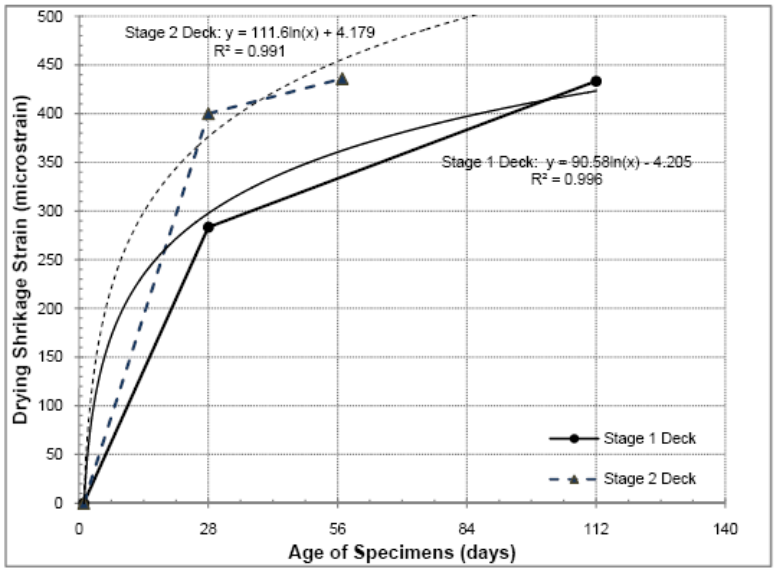
Figure 3-10: Drying Shrinkage Results for Phase 1 Deck Concrete.

Drying shrinkage of the deck concrete was also greater than the test mixes. At 28-days, the deck concrete had shrunk 283 microstrain, shown in Figure 3-10, as compared to Test Mix 1 (the worst case of the trial HPC mixes), which only shrunk 100 microstrain. Stresses from drying shrinkage are expected to be higher for the conventional mix then a HPC mix. To determine the drying shrinkage in the deck at a particular time, the equation shown in Figure 3-10 can be used. Since only three data points were taken, it was assumed that a logarithmic equation would best fit the shrinkage data overtime. The curve seems to overestimate the shrinkage at 28-days and underestimate it at 125-days, but it has only about a 1 to 2 percent error at these times and should be adequate for estimating shrinkage in the deck.

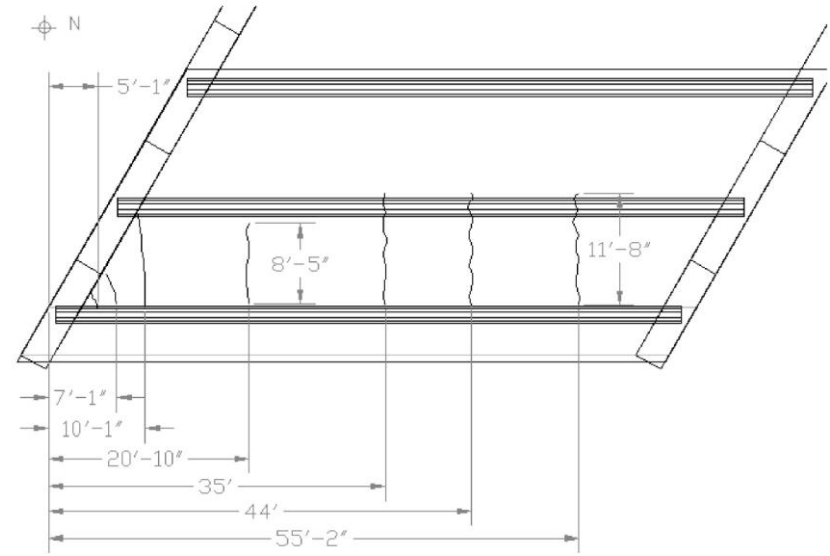
Illustration 4-8: Cracking in the Stage 1 Bridge Deck at 160-Days.

Finally, the skew of the deck for the bridge in review is at the suggested limit. The greater skew of the deck increases the uplift that occurs at the acute angles of the deck. For this deck, the uplift is restrained by the abutments and girders and also by the parapet wall and sidewalk near the corner. Illustration 4-8 shows the cracking that had occurred in the bridge deck up to 4/15/04 (a deck age of 160-days). The adverse effects of skew are apparent by looking at the South East corner of the deck. The cracks at 5 ft 1 in., 7 ft 1 in., and 10 ft 1 in. from the end are all caused by uplift in the deck and the restraint from the parapet wall, sidewalk, and abutments. Further analysis of the cracking shown is presented in Section 5.

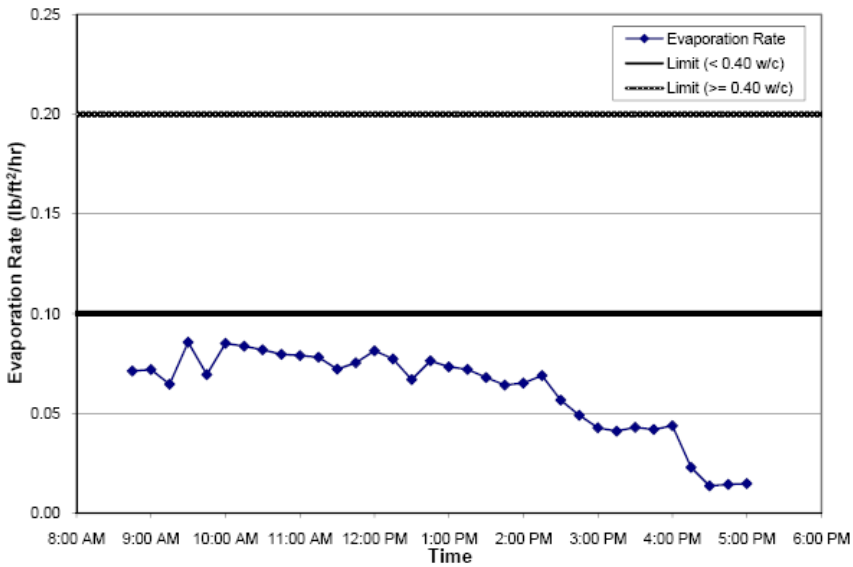
Figure 5-1: Evaporation Rate During Stage 1 Deck Pour.

To determine the evaporation rate while the deck was being poured for Stage 1, Figure 1-1 was used along with the weather data recorded at the UI Plant Science weather station. During this time, the relative humidity and concrete temperature remained fairly constant at 33 percent and 50° F, respectively. Although the air temperature varied between 38° F and 42° F, the evaporation rate was not affected significantly, the evaporation rate nomograph values change very little for a given wind speed below 45° F. Wind speed was the only weather variable that had a significant effect on the evaporation rate. As shown in Figure 5-1, the maximum evaporation rate suggested in section 1.3.1 for concrete with water-to-cement ratio less than 0.40 (0.10 lb/ft^2/hr) was not exceeded. As expected, plastic shrinkage cracking was not observed on the deck.

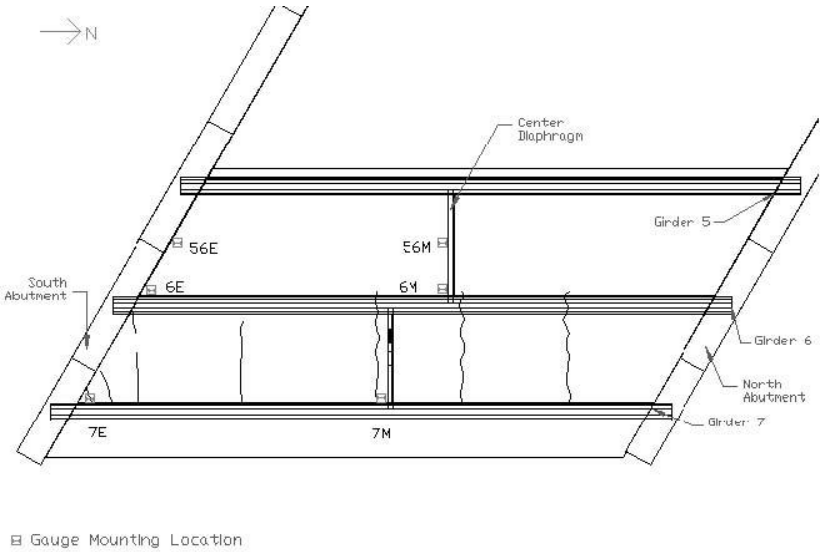
Illustration 5-2: Crack Locations Relative to Gauge Configuration Locations.

Illustration 5-2 shows were the cracks are located relative to the gauges. Note the concentration of cracking that occurs in the acute corner region. As shown, only gauges at locations 7M, 7E, and 6M are near a crack; however, stresses at other gauge locations may have been redistributed when cracking occurred. Visible cracking of the bridge deck was discovered on 3/22/04 after a rainstorm occurred. When the deck is dry or completely saturated the cracks are extremely difficult to detect. Only when the deck is partially moistened are the cracks easily detected; therefore, actual cracking of the deck could have occurred long before they were visibly noted. The majority of the remainder of this section will focus on cracking of the top of the deck by looking at the strain and stress data from the embedment gauges. Cracking of the bottom of the deck is expected and does not affect the overall durability of the deck.

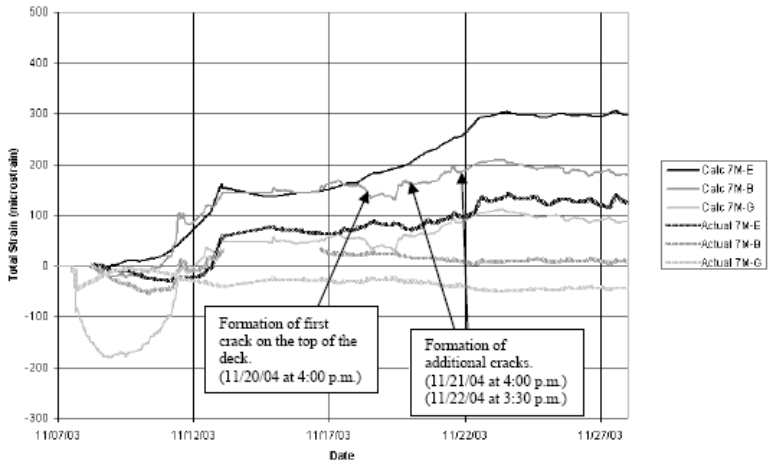
Figure 5-4: Calculated vs. Recorded Strain for Gauge Location 7M.

Looking at the actual strain values is the easiest way to detect when cracking has occurred. In Figure 5-4 a possible time of cracking is shown on 11/20/04 at 4:00 p.m. Cracking can be assumed to occur because the actual strain line for gauge 7M-E has an abrupt change in direction. Although the direction change is minor, it occurs at the same time that the stress diagram, shown in Figure 5-5, exceeds the tensile capacity of the concrete and also has an abrupt drop in tensile stress. Following the initial crack is a series of additional drops in stress on 11/21/04 at 4:00 p.m. and 11/22/04 at 3:30 p.m. Both of these are indicated by extreme changes in the slope of the strain diagram.

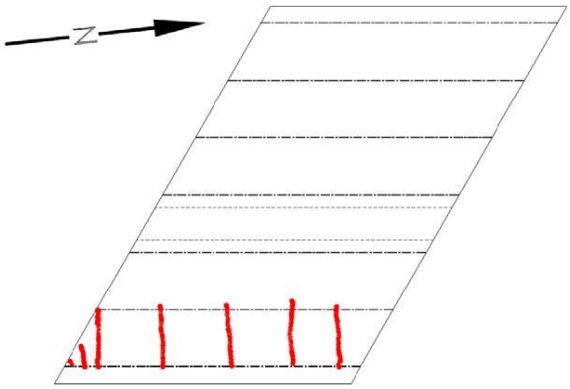
Illustration 6-1: Stage 1 Deck Cracking

Additional cracking near the South East corner of the Stage 1 deck was from traffic loads producing uplift at the acute corner, due to the relatively large skew of the bridge. This cracking is shown in Illustration 6-1. The parapet wall, abutments, girders, and sidewalk all served to restrain the uplift and cause cracking; therefore, the recommendation limiting skew to less than 30° to minimize the risk of cracking, given in Section 1.3.1, will have to be reduced for bridges designed such that the parapet wall and sidewalk are integral with the bridge deck. Additional research will need to be performed to determine the appropriate skew limit.

As shown in Illustration 6-1, Illustration 6-2, Illustration 6-3, and Illustration 6-4, cracking extended significantly past the location of the additional longitudinal end zone reinforcement.

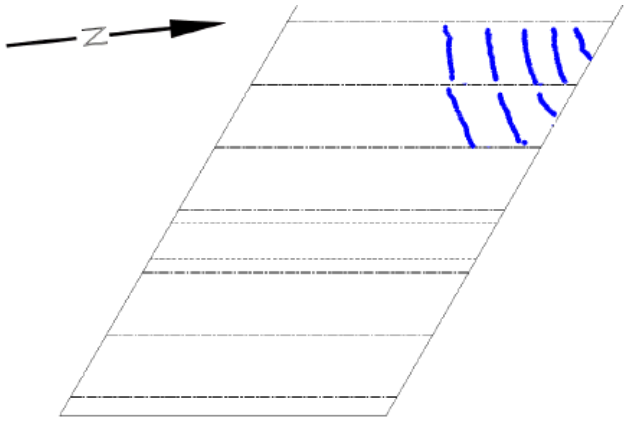
Illustration 6-2: Stage 2 Deck Cracking

After the completion of the Stage 2 deck, similar cracking occurred at the acute corner on the North West corner of the bridge deck, as shown in Illustration 6-2. The details of the cracking in the acute corner of the Stage 2 deck are shown in Illustration 6-3 and Illustration 6-4.

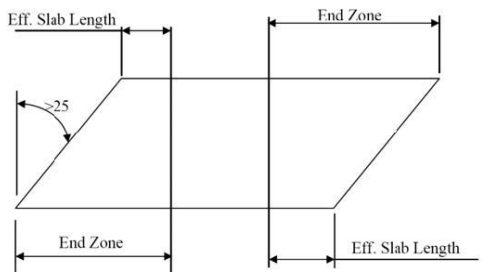
Illustration 6-5: ITD Definition of Skewed End Zones.

The 2001 revision of the ITD Bridge Design Manual defines the end zone for skewed bridges as shown in Illustration 6-5[20].

The US 95 bridge considered in this report has a skew of 30°. Due to the extreme width of the bridge compared to its length, the transverse reinforcing was doubled along the entire length of the bridge and the longitudinal steel was doubled in the end zone[17]. This additional longitudinal end zone reinforcement can be seen in the upper portion of Illustration 6-6. This illustration also shows that outside of the end zones, the longitudinal reinforcement spacing is twice the transverse spacing. Due to the skew and extreme bridge width, the end zone for the additional longitudinal steel was not squared off as depicted in the ITD bridge design manual (Illustration 6-5), but was provided in a region parallel to the ends of the bridge, as shown on Illustration 6-7.

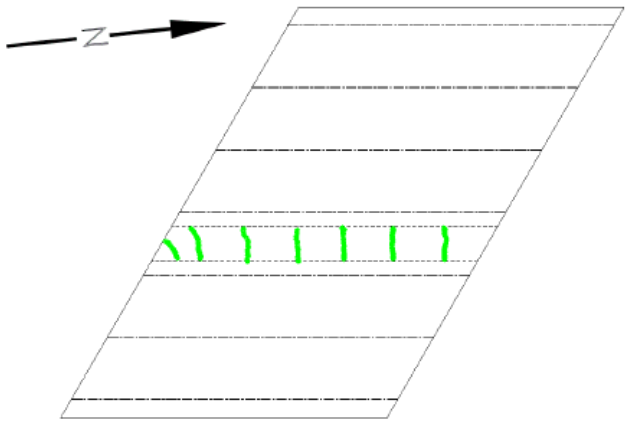
Illustration 6-8: Closure Pour Deck Cracking.

Transverse cracks also occurred at regular intervals throughout the entire length of the closure pour section, as shown in Illustration 6-8 and Illustration 6-9. The closure pour section is continuously restrained along its edges by the hardened Stage 1 and Stage 2 deck concrete. Using development length as an analogy, the first cracks occurred when the strains induced by shrinkage exceed the tensile strength of the concrete. As shown in Illustration 6-10, the cracking will occur at evenly spaced intervals along the entire deck length[21].
